GEOTECHNICAL STUDY AREA G2

LUCCOMBE LANDSLIDE, VENTNOR UNDERCLIFF, ISLE OF WIGHT, UK

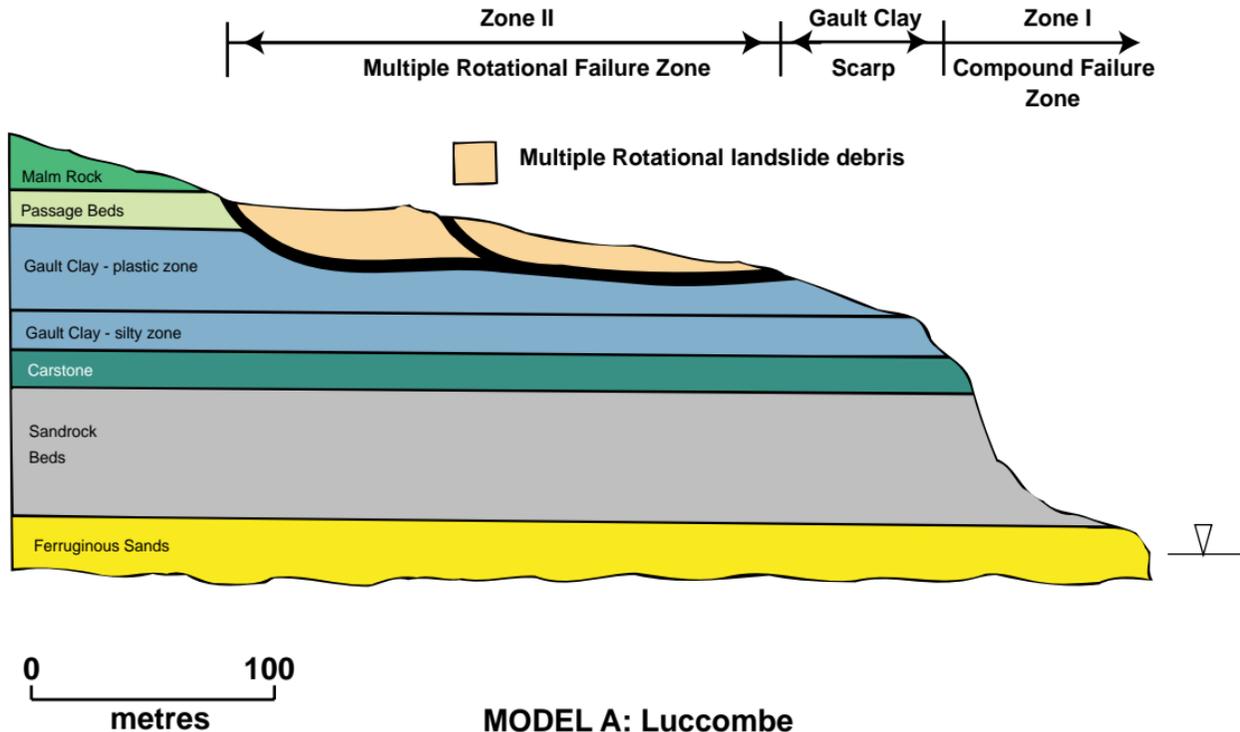
Luccombe is situated on the south coast of the Isle of Wight, 3km north-east of Ventnor. The village lies on the eastern margin of the Southern Downs outlier which is developed in Lower and Upper Cretaceous sedimentary rocks. The Lower Greensand units are well exposed at Luccombe cliff between Luccombe Chine and Shanklin Chine where they dip gently to the south at 1-2°. The base of the Gault Clay is exposed at the top of the cliff whilst the Upper Greensand and Lower Chalk form the inland slopes behind Luccombe Village (Figure G2.2).

Figure G2.2 Luccombe landslip model.

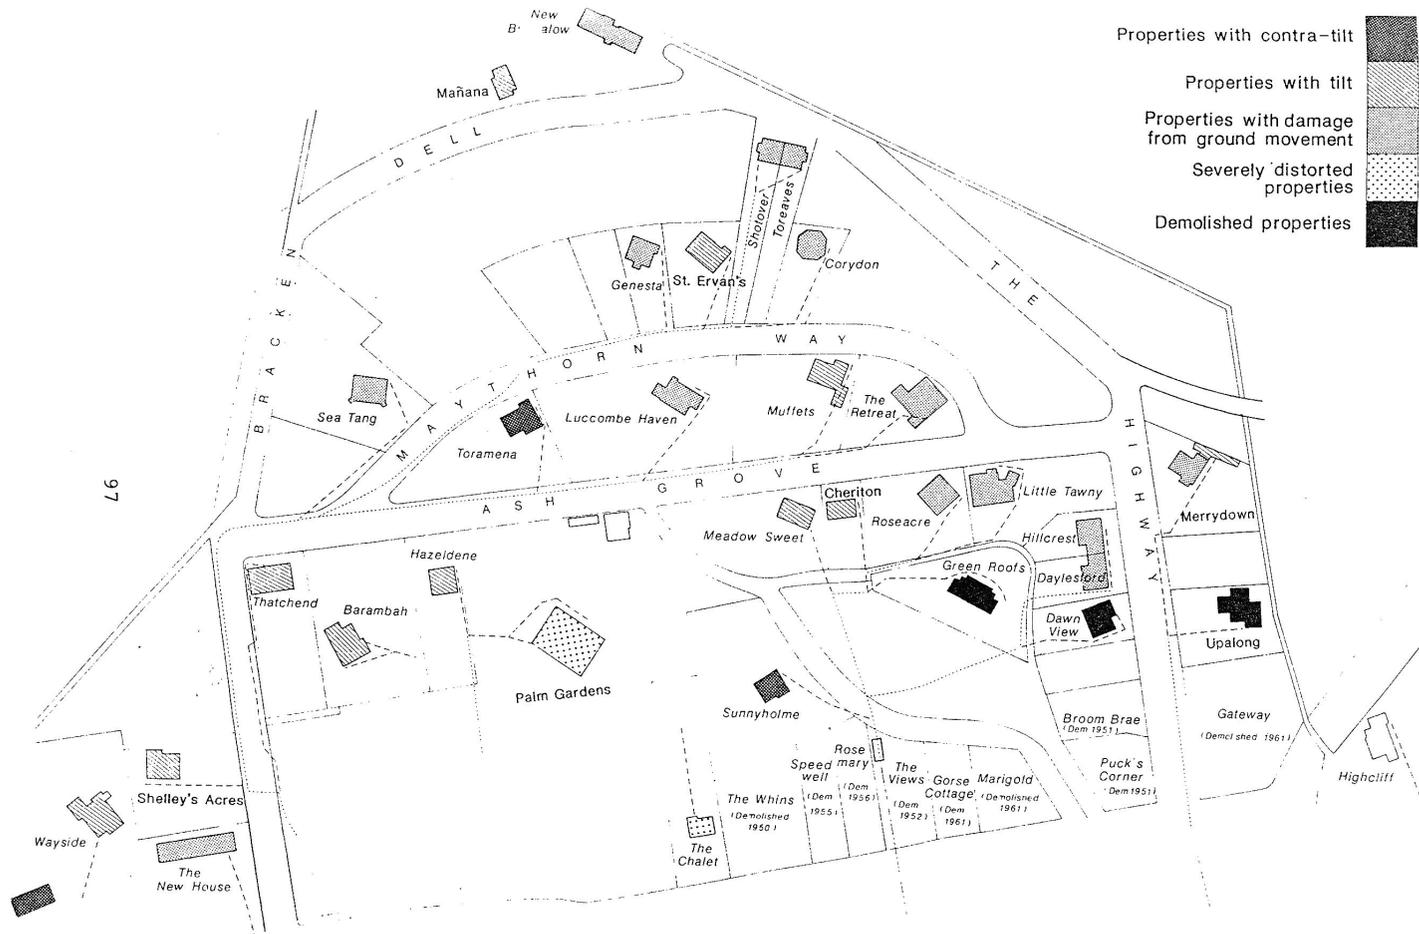
Figure G2.3 Building damage in Luccombe village, 1988.

During the period 1950-1990 Luccombe Village experienced three major phases of landsliding in 1950/51, 1961/62 and 1987/88. The extent of the 1950 and 1961 movements, which resulted in the demolition of three homes, were recorded by the Local Authority at that time. Between 1952 and 1961 a further six properties were demolished. See Figure G2.3 and Plate G2b.

In January 1988 further ground movements resulted in four homes being damaged or demolished. The Council appealed for help and the Luccombe Residents Association was formed in February 1988. The impact of landslide movements over the years at Luccombe has resulted in damage to many properties. The whole community was affected and was anxious to support and to safeguard their livelihood. Anxiety had been promoted from day to day concern of grounds movements occurring to seeking help and compensation and fighting insurance claims.

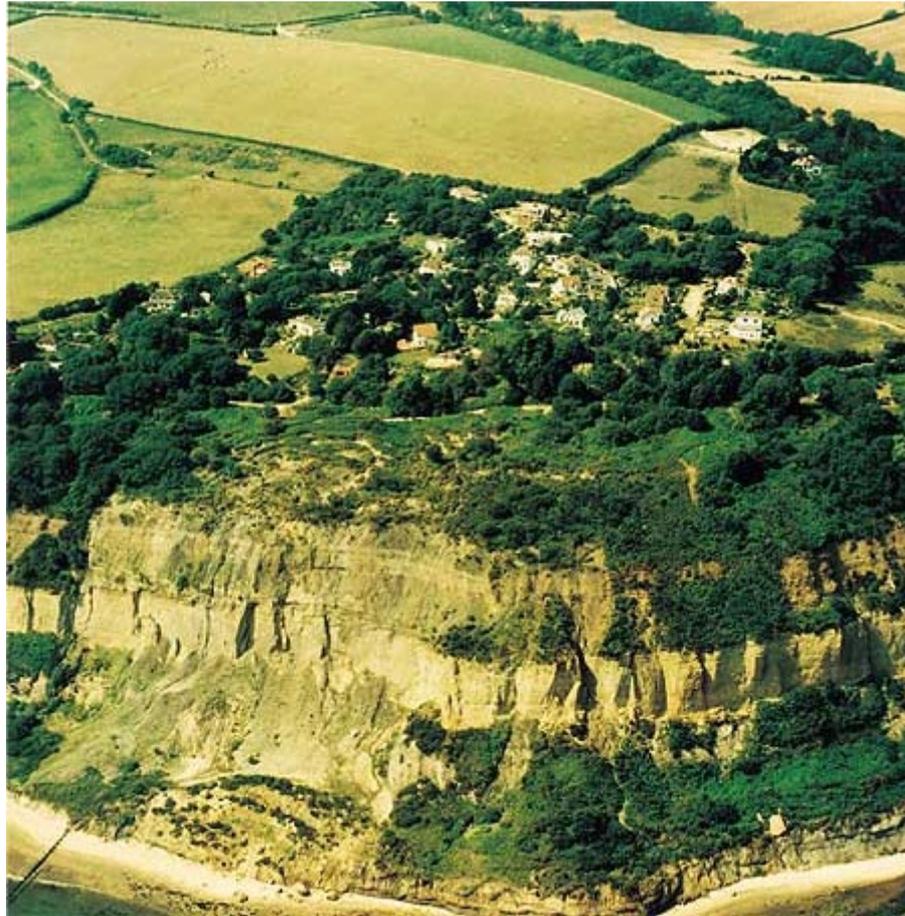
The site at Luccombe Village was built as a private development on open grassland above Shanklin Cliff between 1927 and 1936. Prior to this a small fishing community existed on the foreshore at Luccombe Chine but was destroyed by the great landslip of 1910. Photographic and newspaper evidence of landslide activity in the vicinity of Luccombe Combe prior to 1950 is available and this clearly demonstrates that landslide movements have been recorded in the area for many years. Although there were no reported failures of the sea cliffs, there has been significant cliff retreat over this period, with an estimated rate of erosion of 0.3m per year (Plate G2a).

Plate G2a *Aerial view of Luccombe Village*

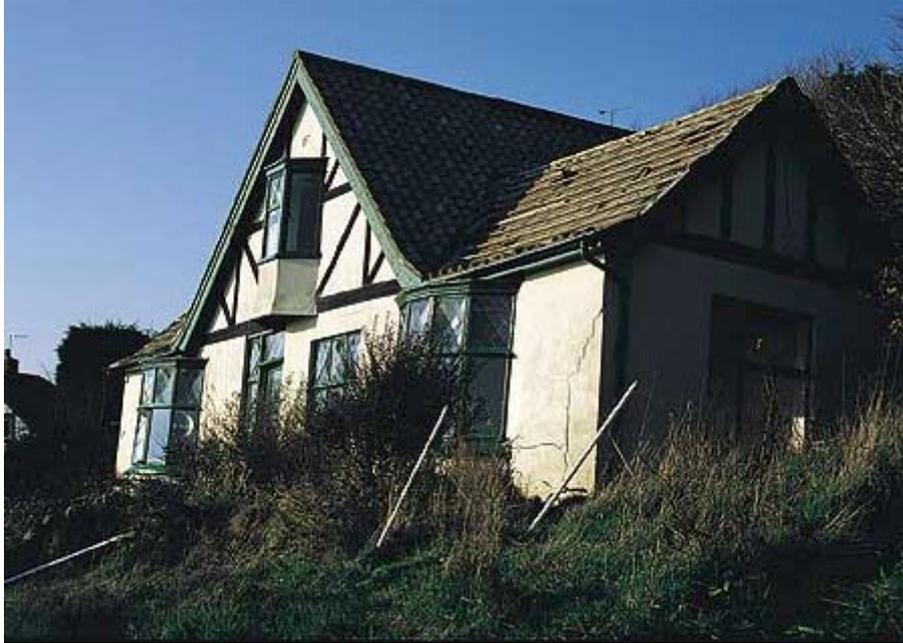
Plate G2b Property damage - Green Rooves, Luccombe (demolished (1988))
