GEOTECHNICAL STUDY AREA G2

LUCCOMBE LANDSLIDE, VENTNOR UNDERCLIFF, ISLE OF WIGHT, UK

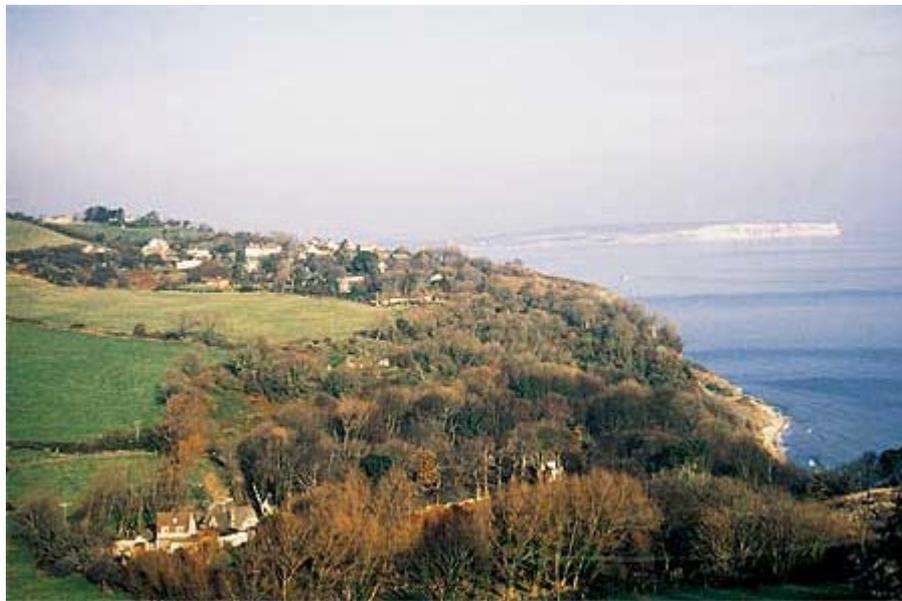
Plate G2 *View from Bonchurch towards Luccombe, Isle of Wight, UK*

In 1987/1988 landslide movements occurred seaward of Luccombe Village at the eastern end of the Isle of Wight Undercliff affecting a number of properties (see Plate G2 and Figure G2.1). These movements were not an isolated event in the area. Geomorphological mapping and analysis of historical documents, including newspapers and postcards indicate the village was built on an ancient landslide system and there has been intermittent movements several times this century. Over the last 50 years in particular the landslide movements have taken the form of periodic reactivations and upslope extension of earlier failures, and have thereby been progressively affecting a larger area of the village.

In January 1988 further ground movements resulted in four homes being damaged or demolished. The Council appealed for help and the Luccombe Residents Association was formed in February 1988. The impact of landslide movements over the years at Luccombe has resulted in damage to many properties. The whole community was affected and was anxious to support and to safeguard their livelihood. Anxiety had been promoted from day to day concern of grounds movements occurring to seeking help and compensation and fighting insurance claims.
